## Duck Cove Marsh Restoration Project North Kingstown, RI

Following the failure of an 18-inch culvert that restricted tidal flushing of Duck Cove, the shores of the cove became dense with Phragmites, an exotic invasive reed. The Duck Cove Bluffs Association called on the Southern Rhode Island Conservation District (SRICD) to help restore the ecology of Duck Cove.

SRICD coordinated the planning, design, and installation of an enlarged culvert (3x4-foot) to enhance tidal flushing to the cove. With the new culvert in place as of November 2001, SRICD began a 5-year monitoring project that already is showing how important salt water intrusion is to eradicating Phragmites and allowing native marsh plant species to return.

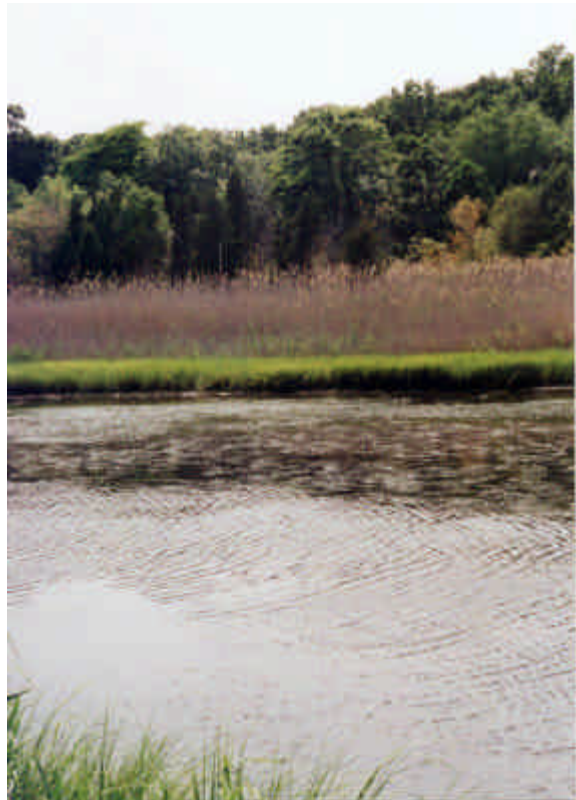
After only one year of enhanced tidal flushing to Duck Cove, the salt water is successfully killing off the Phragmites (the brown reeds seen in the top part of the above photo).

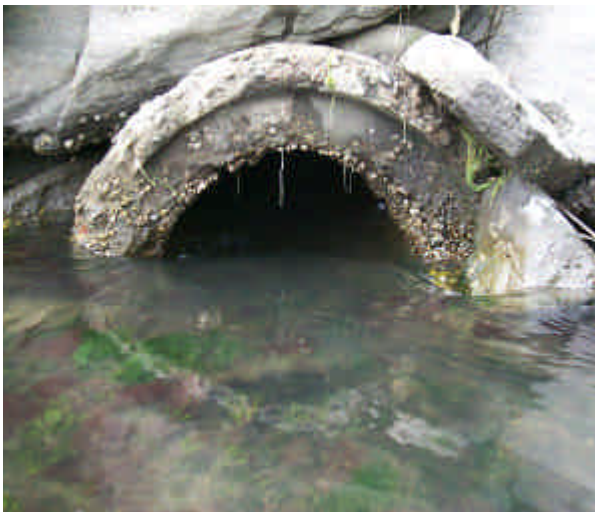
SRICD successfully led the effort to replace an old 18-inch culvert (shown at left) with a 3x4-foot box culvert (shown at right). The new culvert restores tidal flushing, which in turn, is eradicating exotic invasive plants and allowing the return of native marsh plant communities to Duck Cove.
